CRYSTAL LAKE DAM
CT-00341

LOW HAZARD
PHASE I INSPECTION REPORT
NATIONAL PROGRAM OF INSPECTION OF DAMS

Name of Dam:	<u>CRYSTAL LAKE DAM</u>
Inventory Number:	<u>CT 00341</u>
State Located:	<u>CONNECTICUT</u>
County Located:	<u>TOLLAND</u>
Town Located:	<u>STAFFORD/ELLINGTON</u>
Stream:	<u>CRYSTAL LAKE BROOK</u>
Owner:	<u>STAFFORD PRINTERS, INC.</u>
Date of Inspection:	<u>MARCH 1981</u>
Inspection Team:	<u>PETER M. HEYNEN, P.E.</u> <u>JAY A. COSTELLO</u> <u>HECTOR MORENO, P.E.</u>

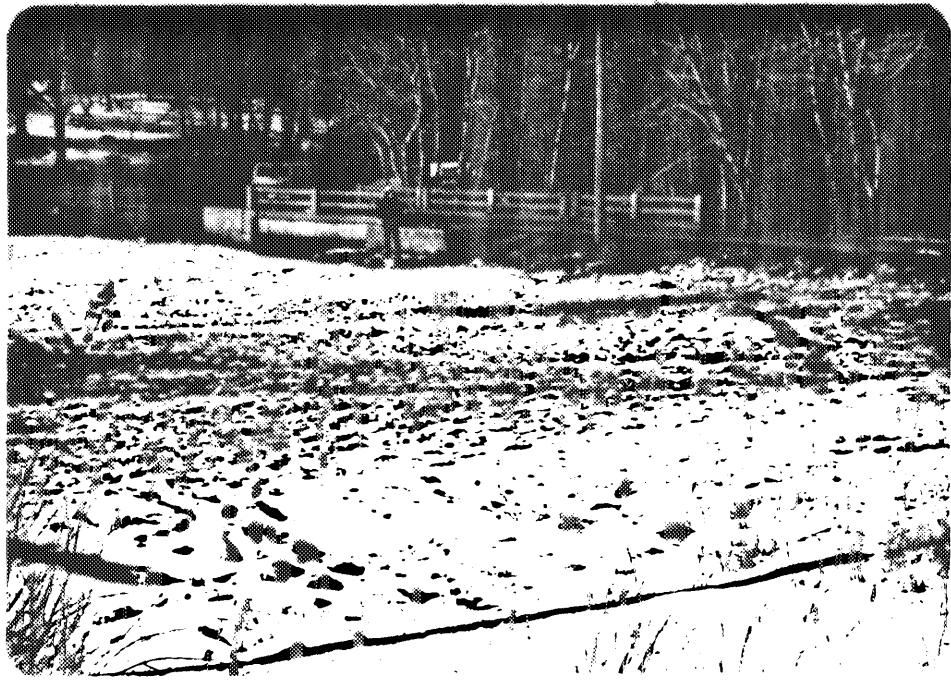
OVERVIEW PHOTO
(MARCH 1981)

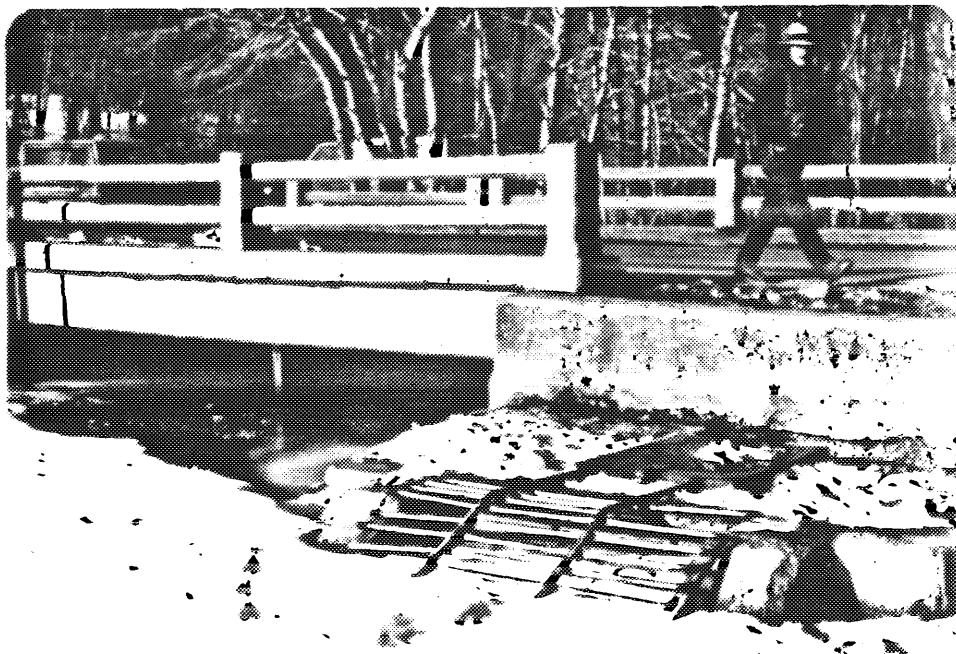
1. The concrete and trash rack at the intake structure are in poor condition and need repair.
2. There is no riprap or vegetation along the upstream slope of the embankment to protect against erosion and sloughing resulting from wave action and runoff.
3. The sides of the spillway discharge channel are eroding, possibly undermining the stone wall in this area.

View of bridge, spillway and intake from upstream side of dam (March 1981).

1. An attempt should be made to inspect the dam during a period of low flow, so a more detailed inspection of the stone spillway structure can be made. Also, the condition of the outlet pipe and intake should be investigated, including operation of the outlet valve.
2. Riprap protection should be placed on the upstream slope between expected high and low water elevations and a grass cover established between the riprap and top of dam. Riprap should also be placed along the banks of the spillway discharge channel to prevent erosion in this area.
3. Large trees should be removed from the dam and within 10 feet of the toe of the dam.
4. Spalling of concrete at the intake structure and bridge abutments should be repaired.
